US 50 Pedestrian and Bicyclist Safety and Connectivity Study

June 2014

Salisbury-Wicomico
Metropolitan Planning
Organization

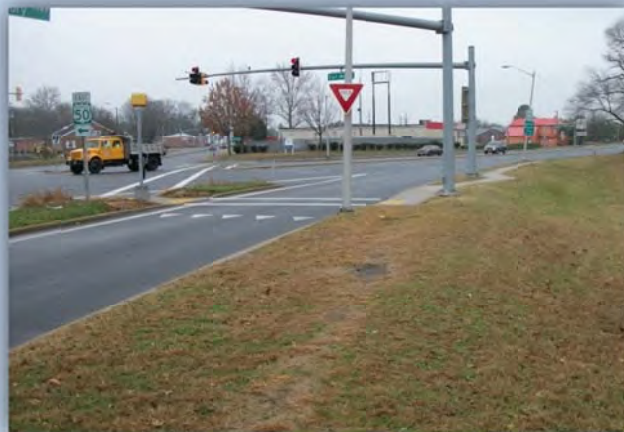
Example Deficiency 1 – Lack of Sidewalk Connectivity

There were several locations identified within the Study area where there was no sidewalk available; however, there were worn paths visible in the vegetation indicating pedestrians are actively using the route.

- General pedestrian facility deficiency.
- Unstable and irregular walking surface.
- Pedestrians may alternatively choose to unsafely walk within adjacent travel lane.

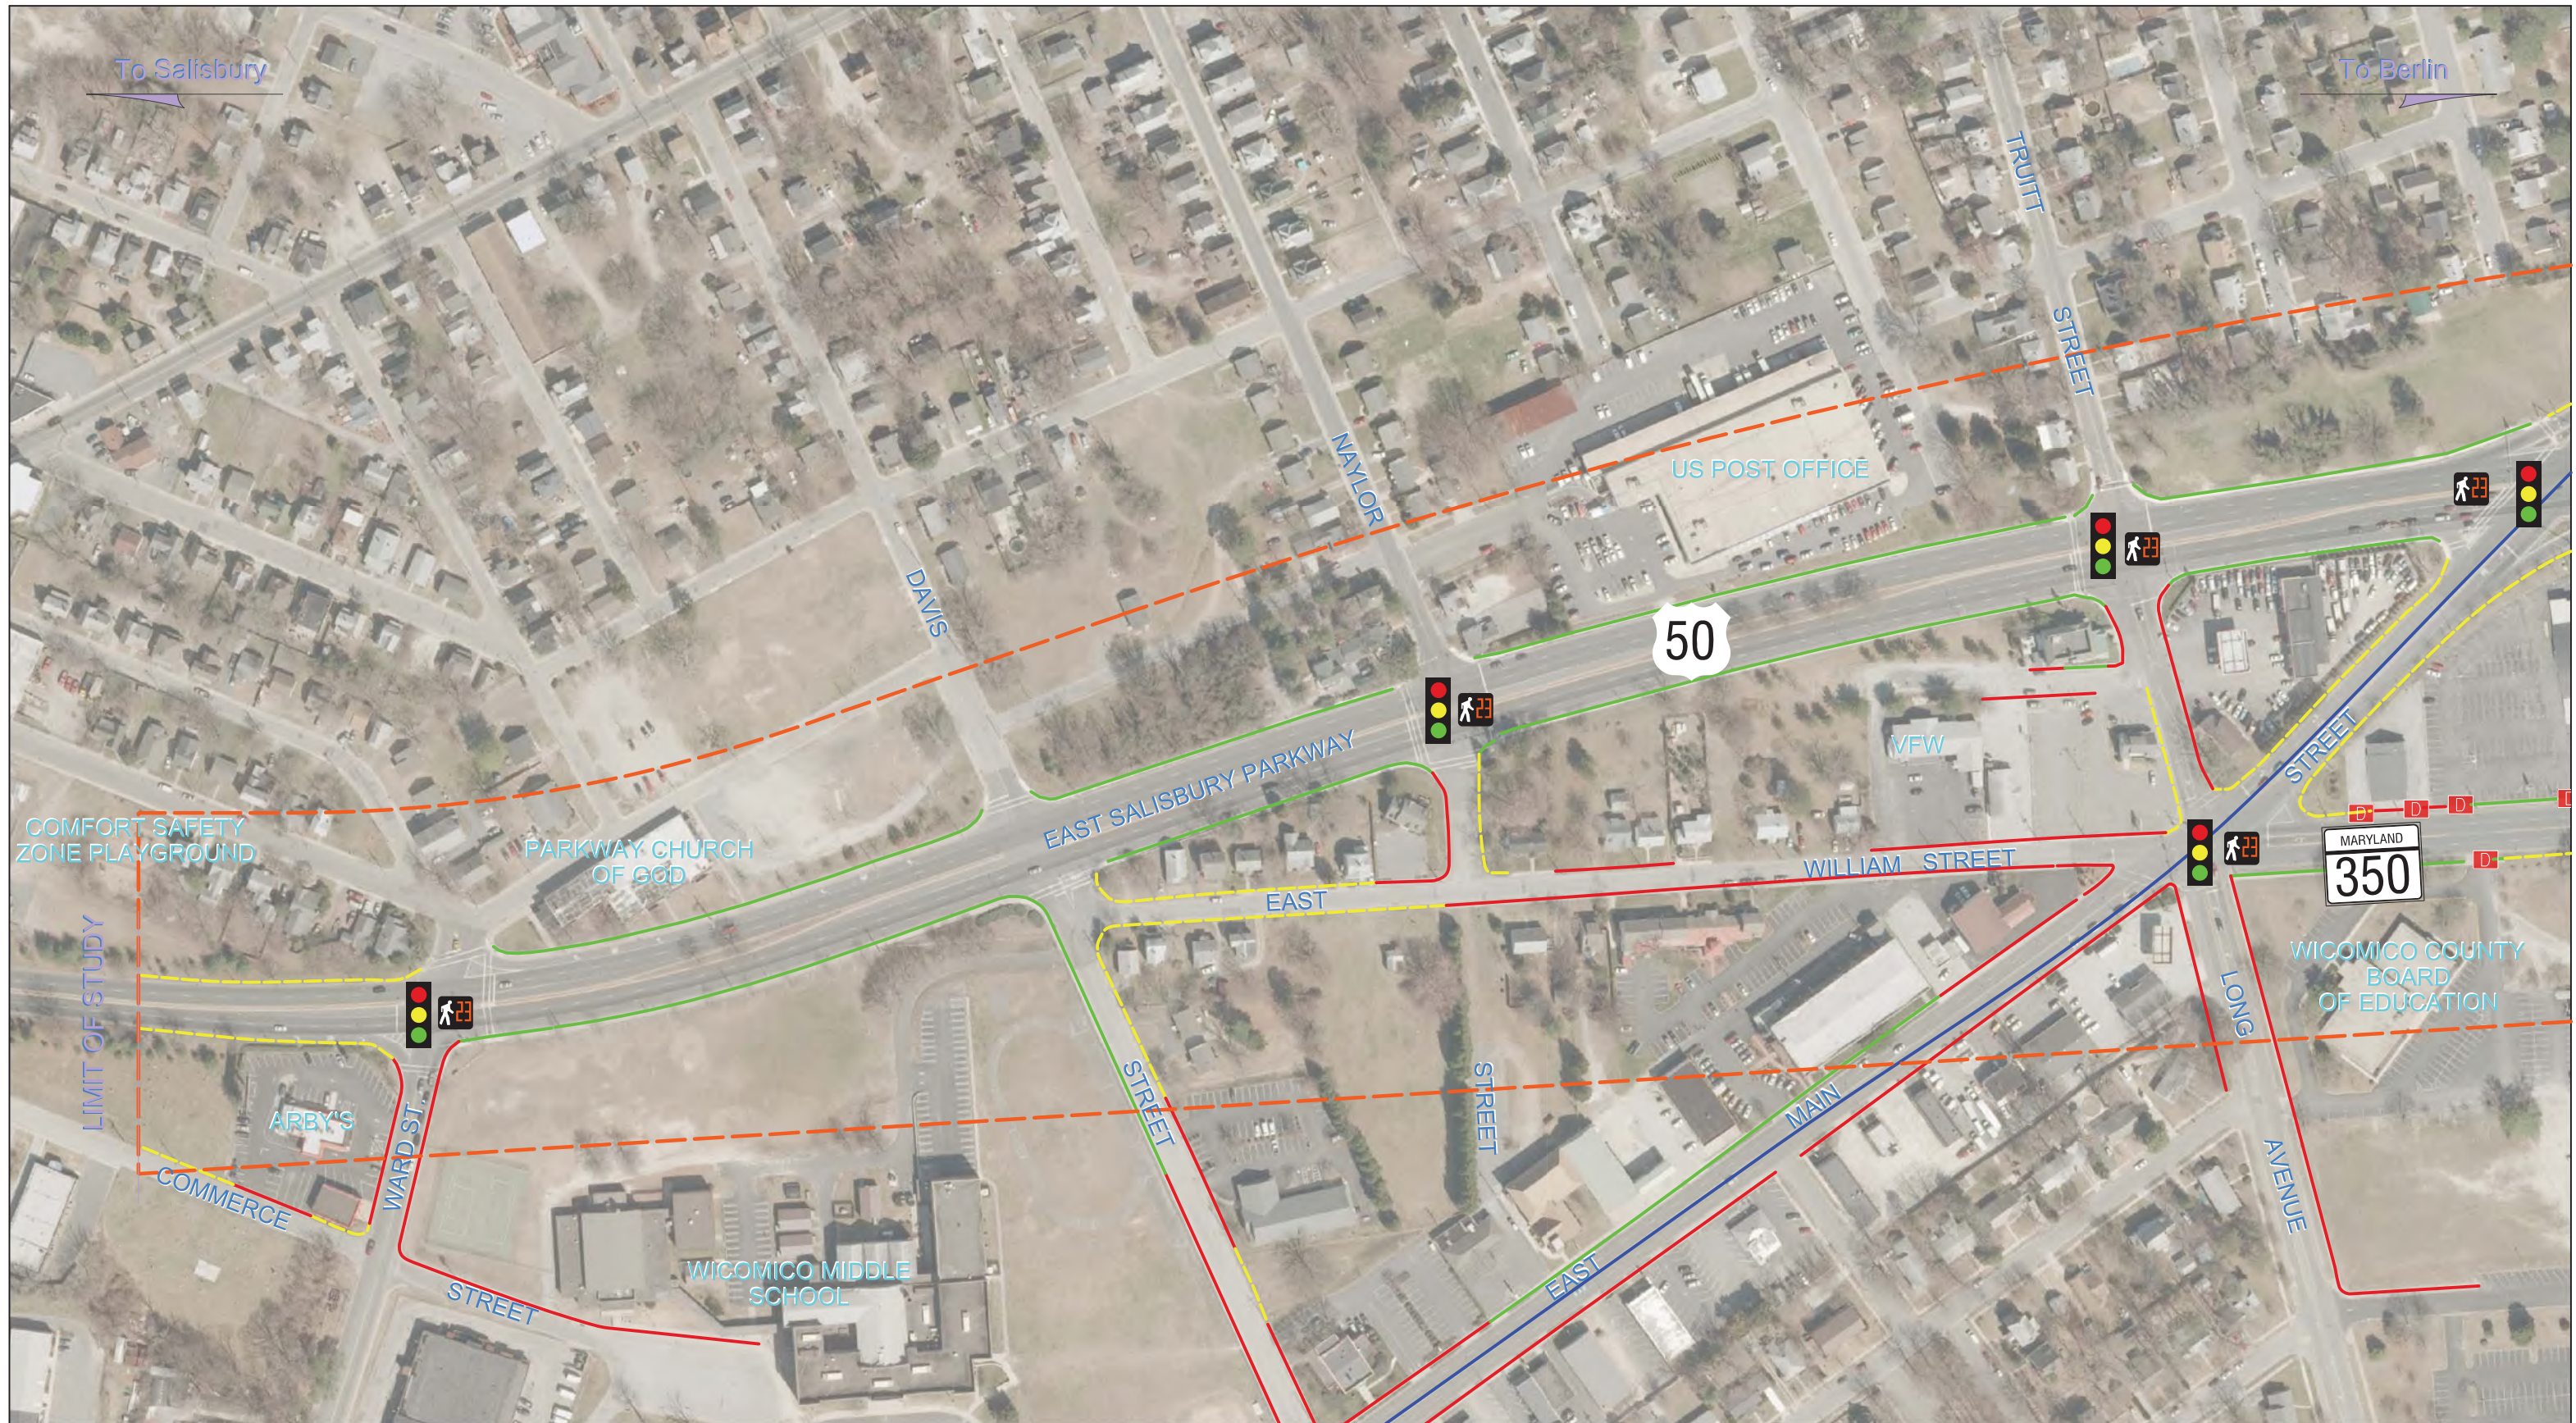
FIGURE NO.
2

EXISTING CONDITIONS PEDESTRIAN AND BICYCLE FACILITIES

As shown in **Figures 2-4**, US 50 Business contains sidewalk from Ward Street, and points west, to the East Main Street intersection. At the US 50 Business and East Main Street intersection, pedestrians cannot travel north or south along East Main Street due to missing sidewalk. In addition, pedestrians are also unable to continue east along US 50 Business due to the lack of pedestrian facilities along this section of roadway; therefore, pedestrian must reverse course and travel west along U.S. 50 business.

East William Street/Mt. Hermon Road, the southern east-west roadway within the study area, also contains sidewalk but this sidewalk is not continuous throughout the study area. There are several missing segments located along East William Street and one missing sidewalk section along eastbound Mt. Hermon Road located just east of the Mt. Hermon Road and East Main Street intersection.

Within the Study area, several locations were found to have inaccessible sidewalk. These locations include East William Street, East Main Street, and several locations along Mt. Hermon Road. See **Figures 2, 3, and 4**.

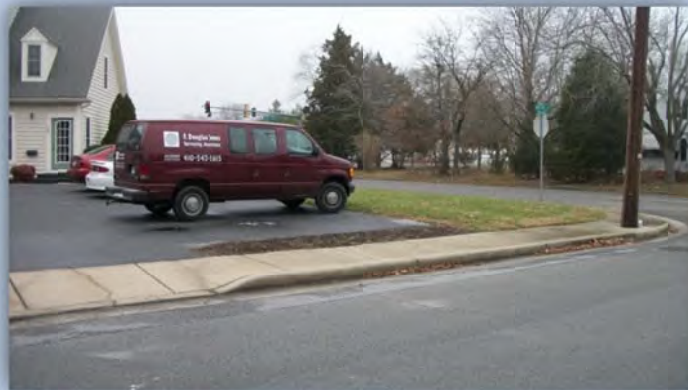
Example Deficiency 2 – Inaccessible Sidewalk

Inaccessible sidewalks are defined as those currently existing; however, they do not meet the minimum requirements for ADA compliant sidewalk. Inadequate cross slopes, grades, and/or dimensions could each lead to a sidewalk being identified as inaccessible.

- **General and ADA pedestrian facility deficiency.**
- **Unstable/slippery walking surface.**
- **Excessive cross slope (>2%)**
- **Lack of 4-foot wide minimum clear.**
- **Obstructions in path of travel.**

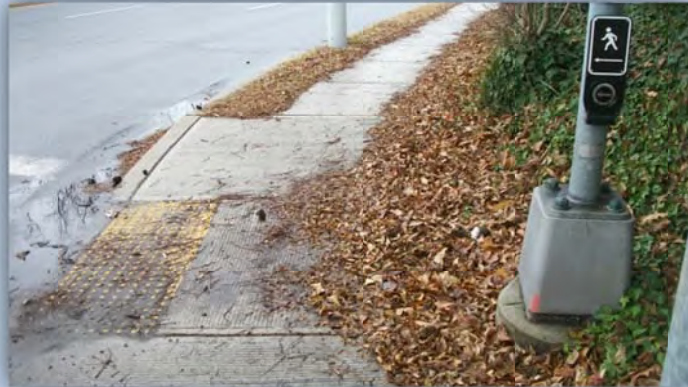
Example Deficiency 3 – Deteriorated/Unmaintained Sidewalk

There were multiple locations throughout the Study area where sidewalk was found to be deteriorated or left unmaintained. These locations can hinder the pedestrian's ability to walk along the intended sidewalk path.

- General and ADA pedestrian facility deficiency.
- Unstable/slippery walking surface.
- Lack of 4-foot wide minimum clear path.
- Detectable warning surface domes filled with debris making detection difficult.

During the field visit, several locations were found to require maintenance. These locations included the U.S. 50 Business and Davis Street intersection corners, sidewalk along eastbound U.S. 50 Business east of Naylor Street, and the sidewalk along East William Street.

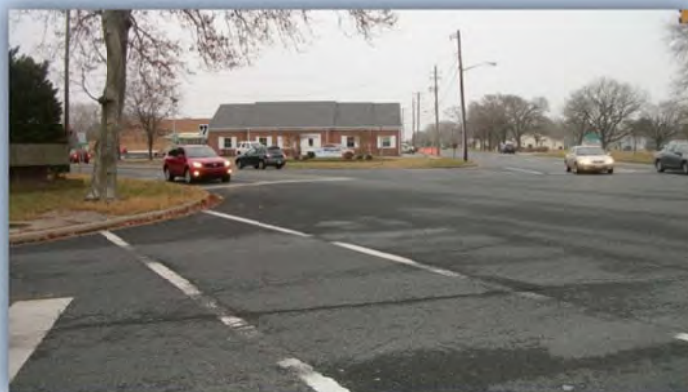
Example Deficiency 4 – Missing Pedestrian Curb Ramps

- General and ADA pedestrian facility deficiency.
- Crosswalk striping indicates intended pedestrian path.
- Lack of curb ramp makes sidewalk inaccessible.

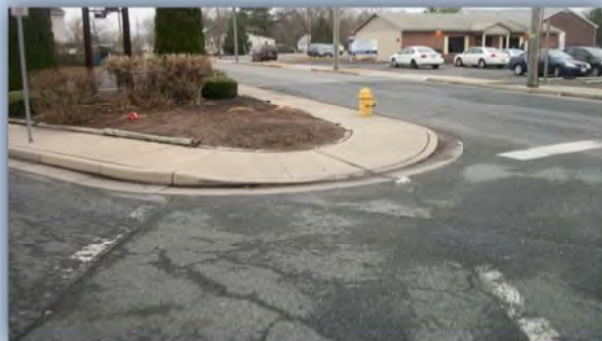
Example Deficiency 5 – Inaccessible Pedestrian Curb Ramps

Inaccessible pedestrian curb ramps are defined as those that currently exist, but do not meet the minimum requirements for an ADA compliant pedestrian curb ramp. Inadequate cross slopes, grades, widths, or lack of detectable warning surfaces could each lead to a pedestrian curb ramp as being identified as inaccessible.

- **ADA pedestrian facility deficiency.**
- **Cross slopes and ramp transition grades exceed maximum allowable.**
- **No detectable warning surface.**

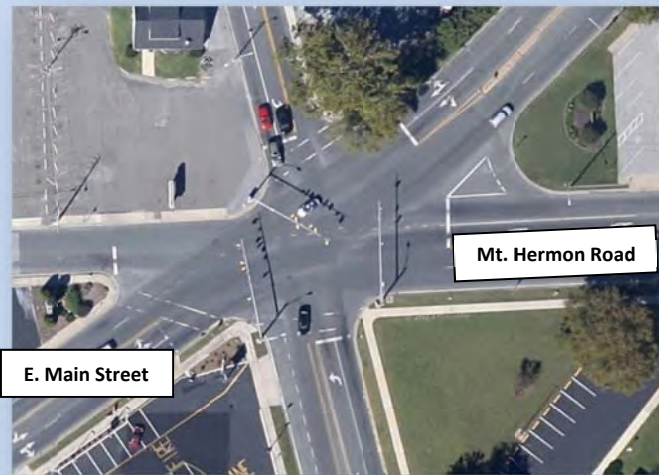
Example Deficiency 6 – Unclear Intended Pedestrian Route

Several locations within the project limits do not contain clear pedestrian route indications. These locations make it difficult for pedestrians and bicyclists to safely navigate areas within the project limits. Lack of pedestrian ramps, offset curb lines, and lack of/worn crosswalk markings attribute to unclear pedestrian and bicyclist route delineation.

- General pedestrian facility deficiency.
- Unclear intended pedestrian route leads to jaywalking.
- Difficult to navigate intersection for pedestrians and bicyclists.

Several locations exist within the study limits where the intended pedestrian route is either ambiguous or preferred by pedestrians as the route would require a further distance than wanted. These locations include the East Main Street and Mt. Hermon Road intersection and the U.S. Route 50 Business and Davis Street intersection.

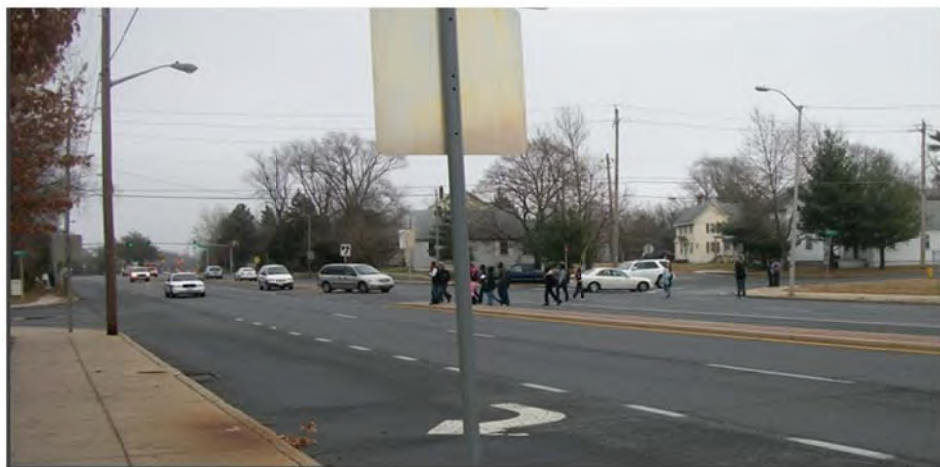
Figure 5: U.S. 50 Business and Davis Street Pedestrians

The information presented in **Table 1** includes the total AM and PM pedestrian crossings, which occurred during the time of the counts. As indicated in the Table by an asterisk, pedestrians frequently crossed U.S. 50 Business via an undesignated approach. The signalized intersections along U.S. Route 50 at Ward Street, Truitt Street, and East Main Street intersections all contain one (1) pedestrian crossing, which includes a pedestrian push button and pedestrian traffic signal. The Ward Street pedestrian crossing is located on the east intersection approach while the Truitt Street and East Main Street pedestrian crossings are located on the west approaches. As is evident from the data, there is a high non-compliance exhibited when pedestrians are crossing U.S. 50 Business. This is especially significant at the U.S. 50 Business and Davis Street intersection where there are no designated pedestrian crossings of U.S. 50 Business. Yet, 93 of the 109 crossings counted, or 85 percent of pedestrians at this intersection crossed U.S. 50 Business. Unlike the Ward Street, Truitt Street, and East Main Street intersections where vehicular traffic must occasionally stop because of a red traffic signal, there are no traffic control devices on U.S. 50 Business at the Davis Street intersection. Pedestrians frequently enter live traffic to cross U.S. 50 Business as shown in **Figure 5**. In addition, the majority of these crossings occurred between 7:15 AM and 7:45 AM and between 2:30 PM and 3:15 PM, corresponding directly to the opening and closing times of Wicomico Middle and High Schools. This occurrence indicates the majority of pedestrians are school aged children. In an effort to reduce pedestrian crossings from occurring at this location, Wicomico Middle School repeats an announcement several times on the intercom system advising students to cross U.S. 50 Business at the Ward Street intersection, which is signalized and has a crossing guard, and not at the Davis Street intersection.

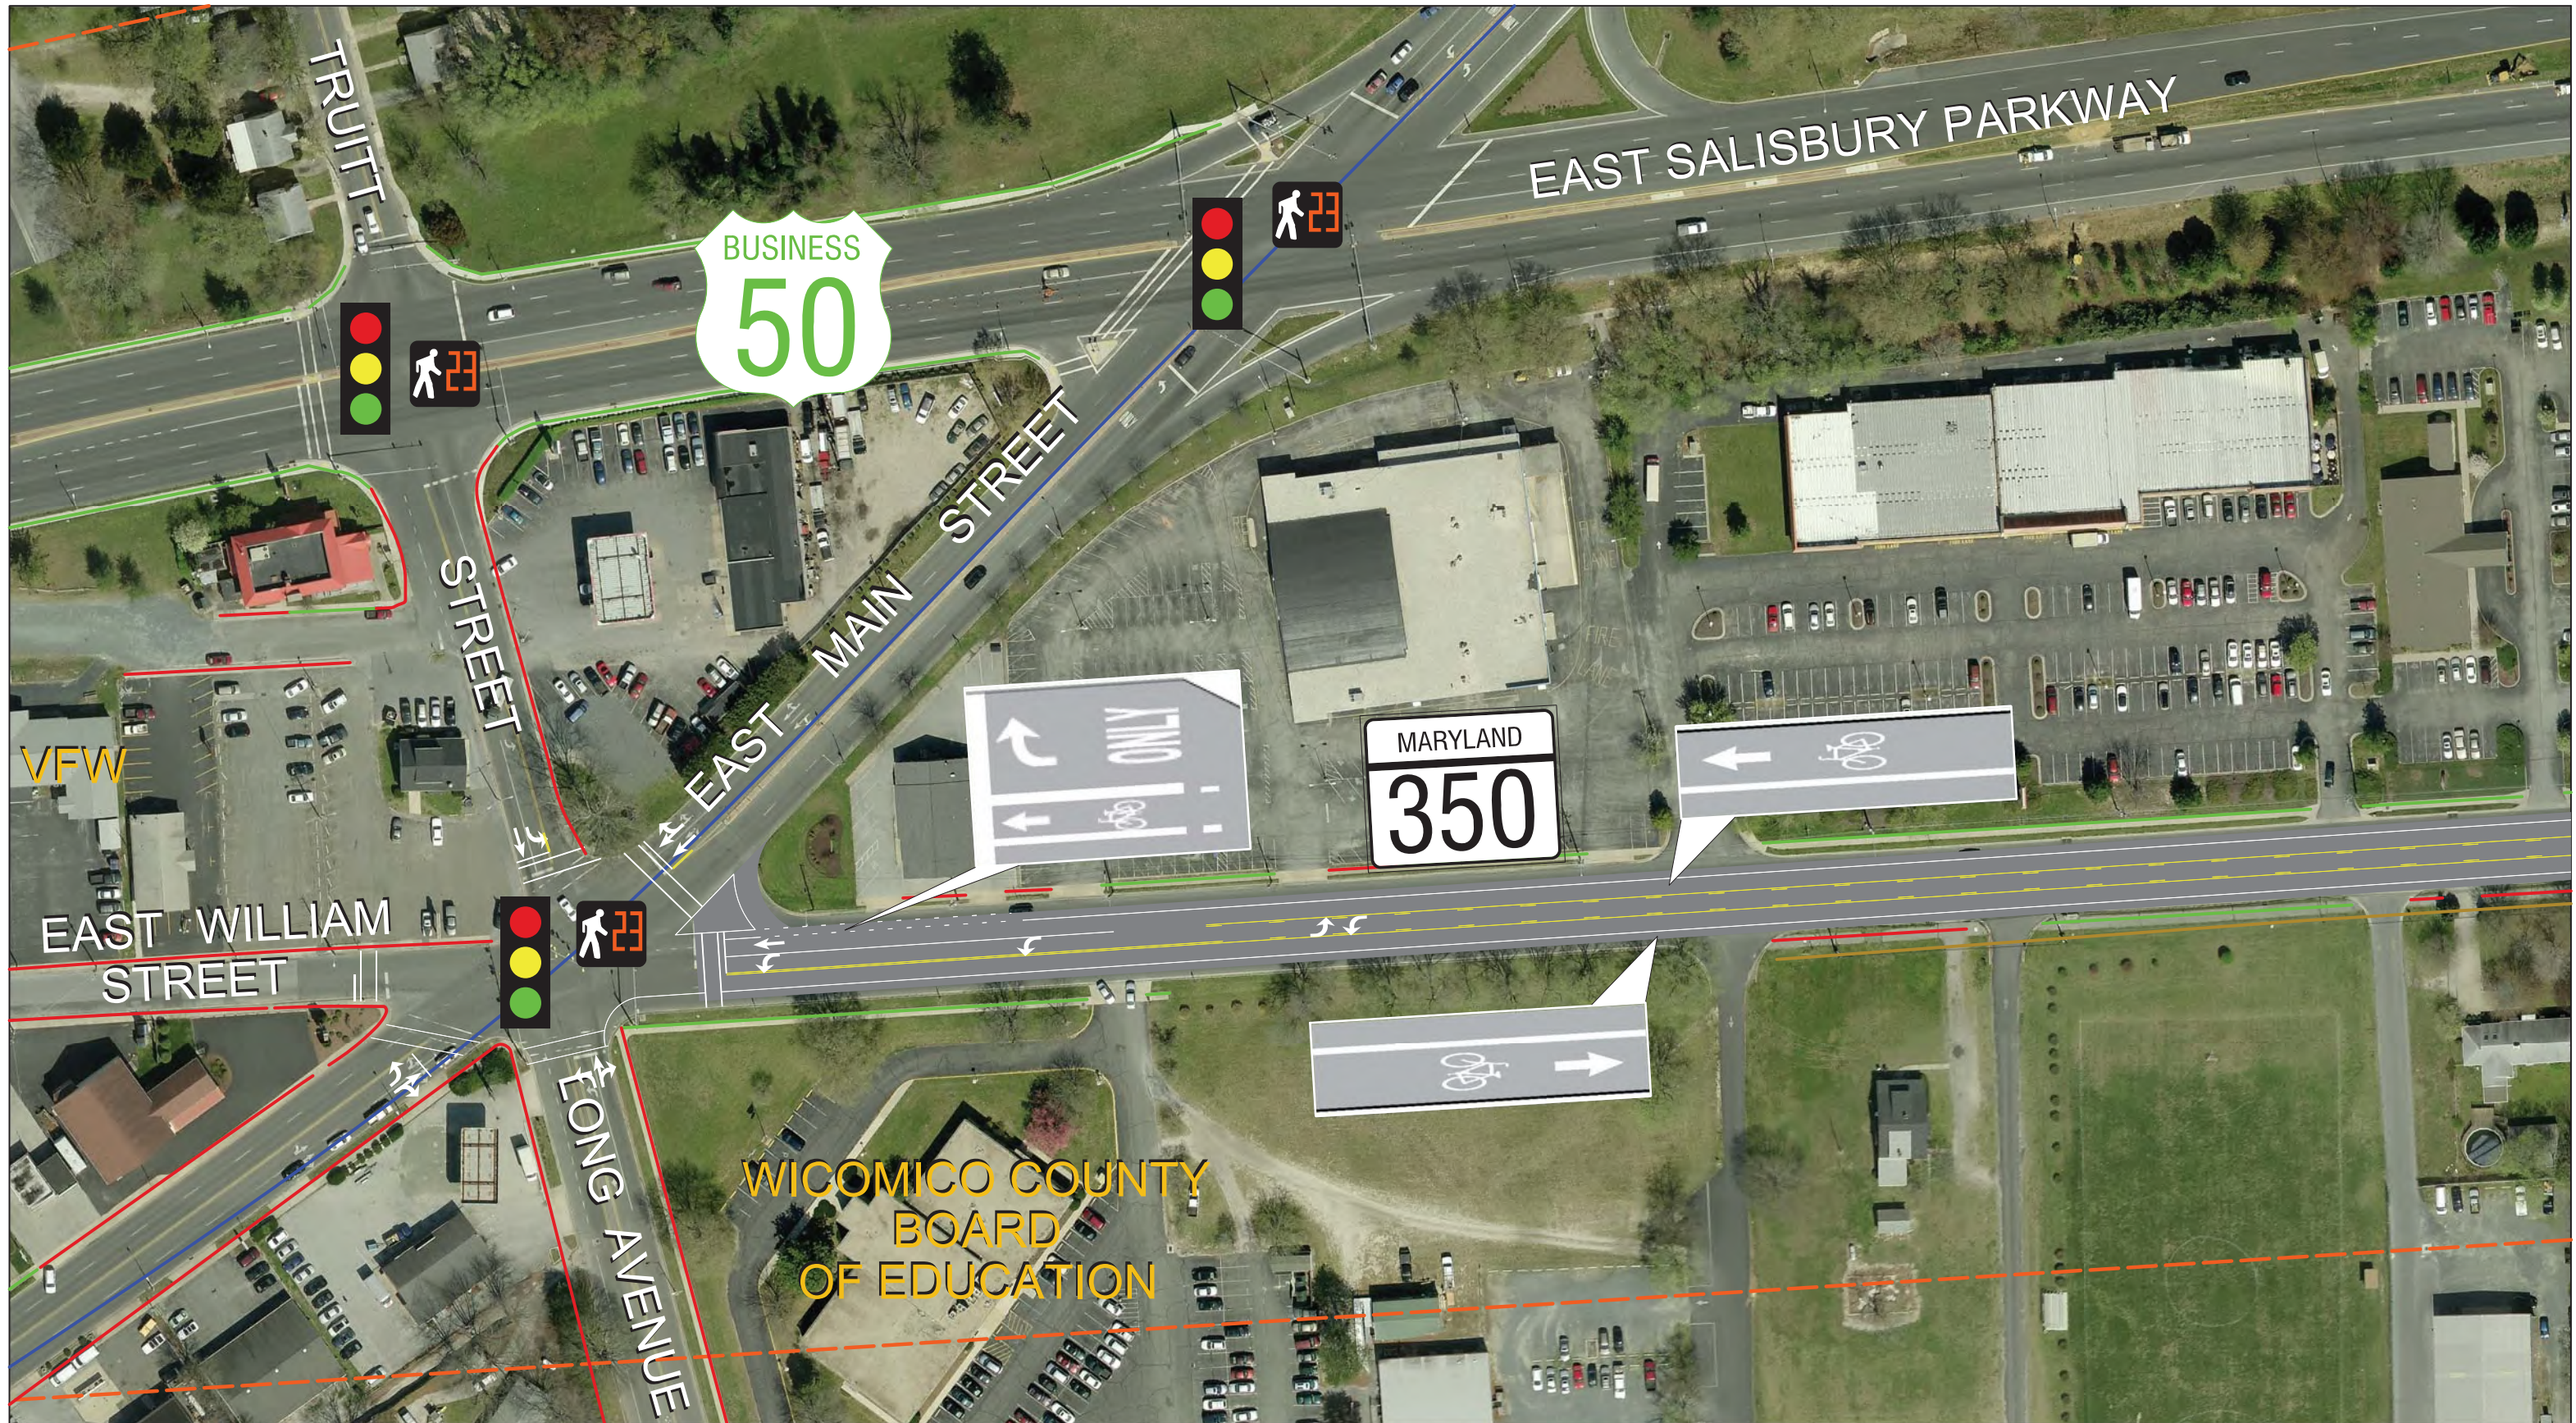
FIGURE NO.
15

This corridor is well suited for a “Road Diet.” Application of a Road Diet to this corridor would involve restriping the entire roadway to include one westbound lane, one eastbound lane, and one center two-way-left-turn-lane as shown in **Figures 15-18**. A Road Diet is generally applicable on roadways with average daily traffic volumes of 20,000 vehicles or less under, which Mt. Hermon Road operates. In addition to this modification, an on-road dedicated bicycle lane would be added in each direction. This bicycle lane would connect the proposed Beaglin Park Drive bike path located at the eastern terminus to the East Main Street State bicycle route and Salisbury City Park at the western terminus. Application of this improvement would allow turning vehicles to enter the center turn lane prior to turning and would also require those vehicles to yield to only one lane of oncoming traffic. The cost associated with this Level 3 recommendation would essentially be negligible if the improvement is applied during the next scheduled resurfacing project for Mt. Hermon Road. However, if the improvement were to be programmed, the cost of the full improvement is estimated at approximately \$800,000. A graphical rendering of this improvement is presented in **Figure 19**.

Mt. Hermon Road Corridor from East Main Street to Beaglin Park Drive – This section of roadway is currently four lanes total, two in the westbound and two in the eastbound direction. There is either sidewalk or a bicycle path along the majority of the corridor; however, there are a few missing segments. This corridor serves many of the businesses within the Study area and because of this, there are many access points located on the roadway. In order for vehicles to enter these businesses, they must turn from the left lane and yield to two lanes of oncoming traffic. In addition, drivers must account for pedestrians walking on the sidewalks and through the driveway crossings as they navigate their vehicles through the business entrances.
