# US 50 Pedestrian and Bicyclist Safety and Connectivity Study

June 2014

Salisbury-Wicomico  
Metropolitan Planning  
Organization

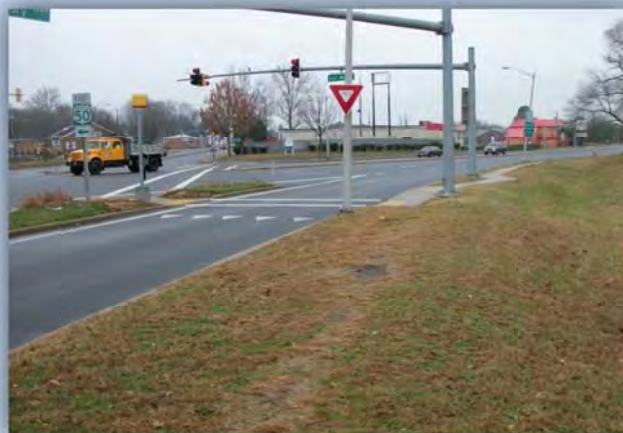
#### Example Deficiency 1 – Lack of Sidewalk Connectivity

There were several locations identified within the Study area where there was no sidewalk available; however, there were worn paths visible in the vegetation indicating pedestrians are actively using the route.

- General pedestrian facility deficiency.
- Unstable and irregular walking surface.
- Pedestrians may alternatively choose to unsafely walk within adjacent travel lane.

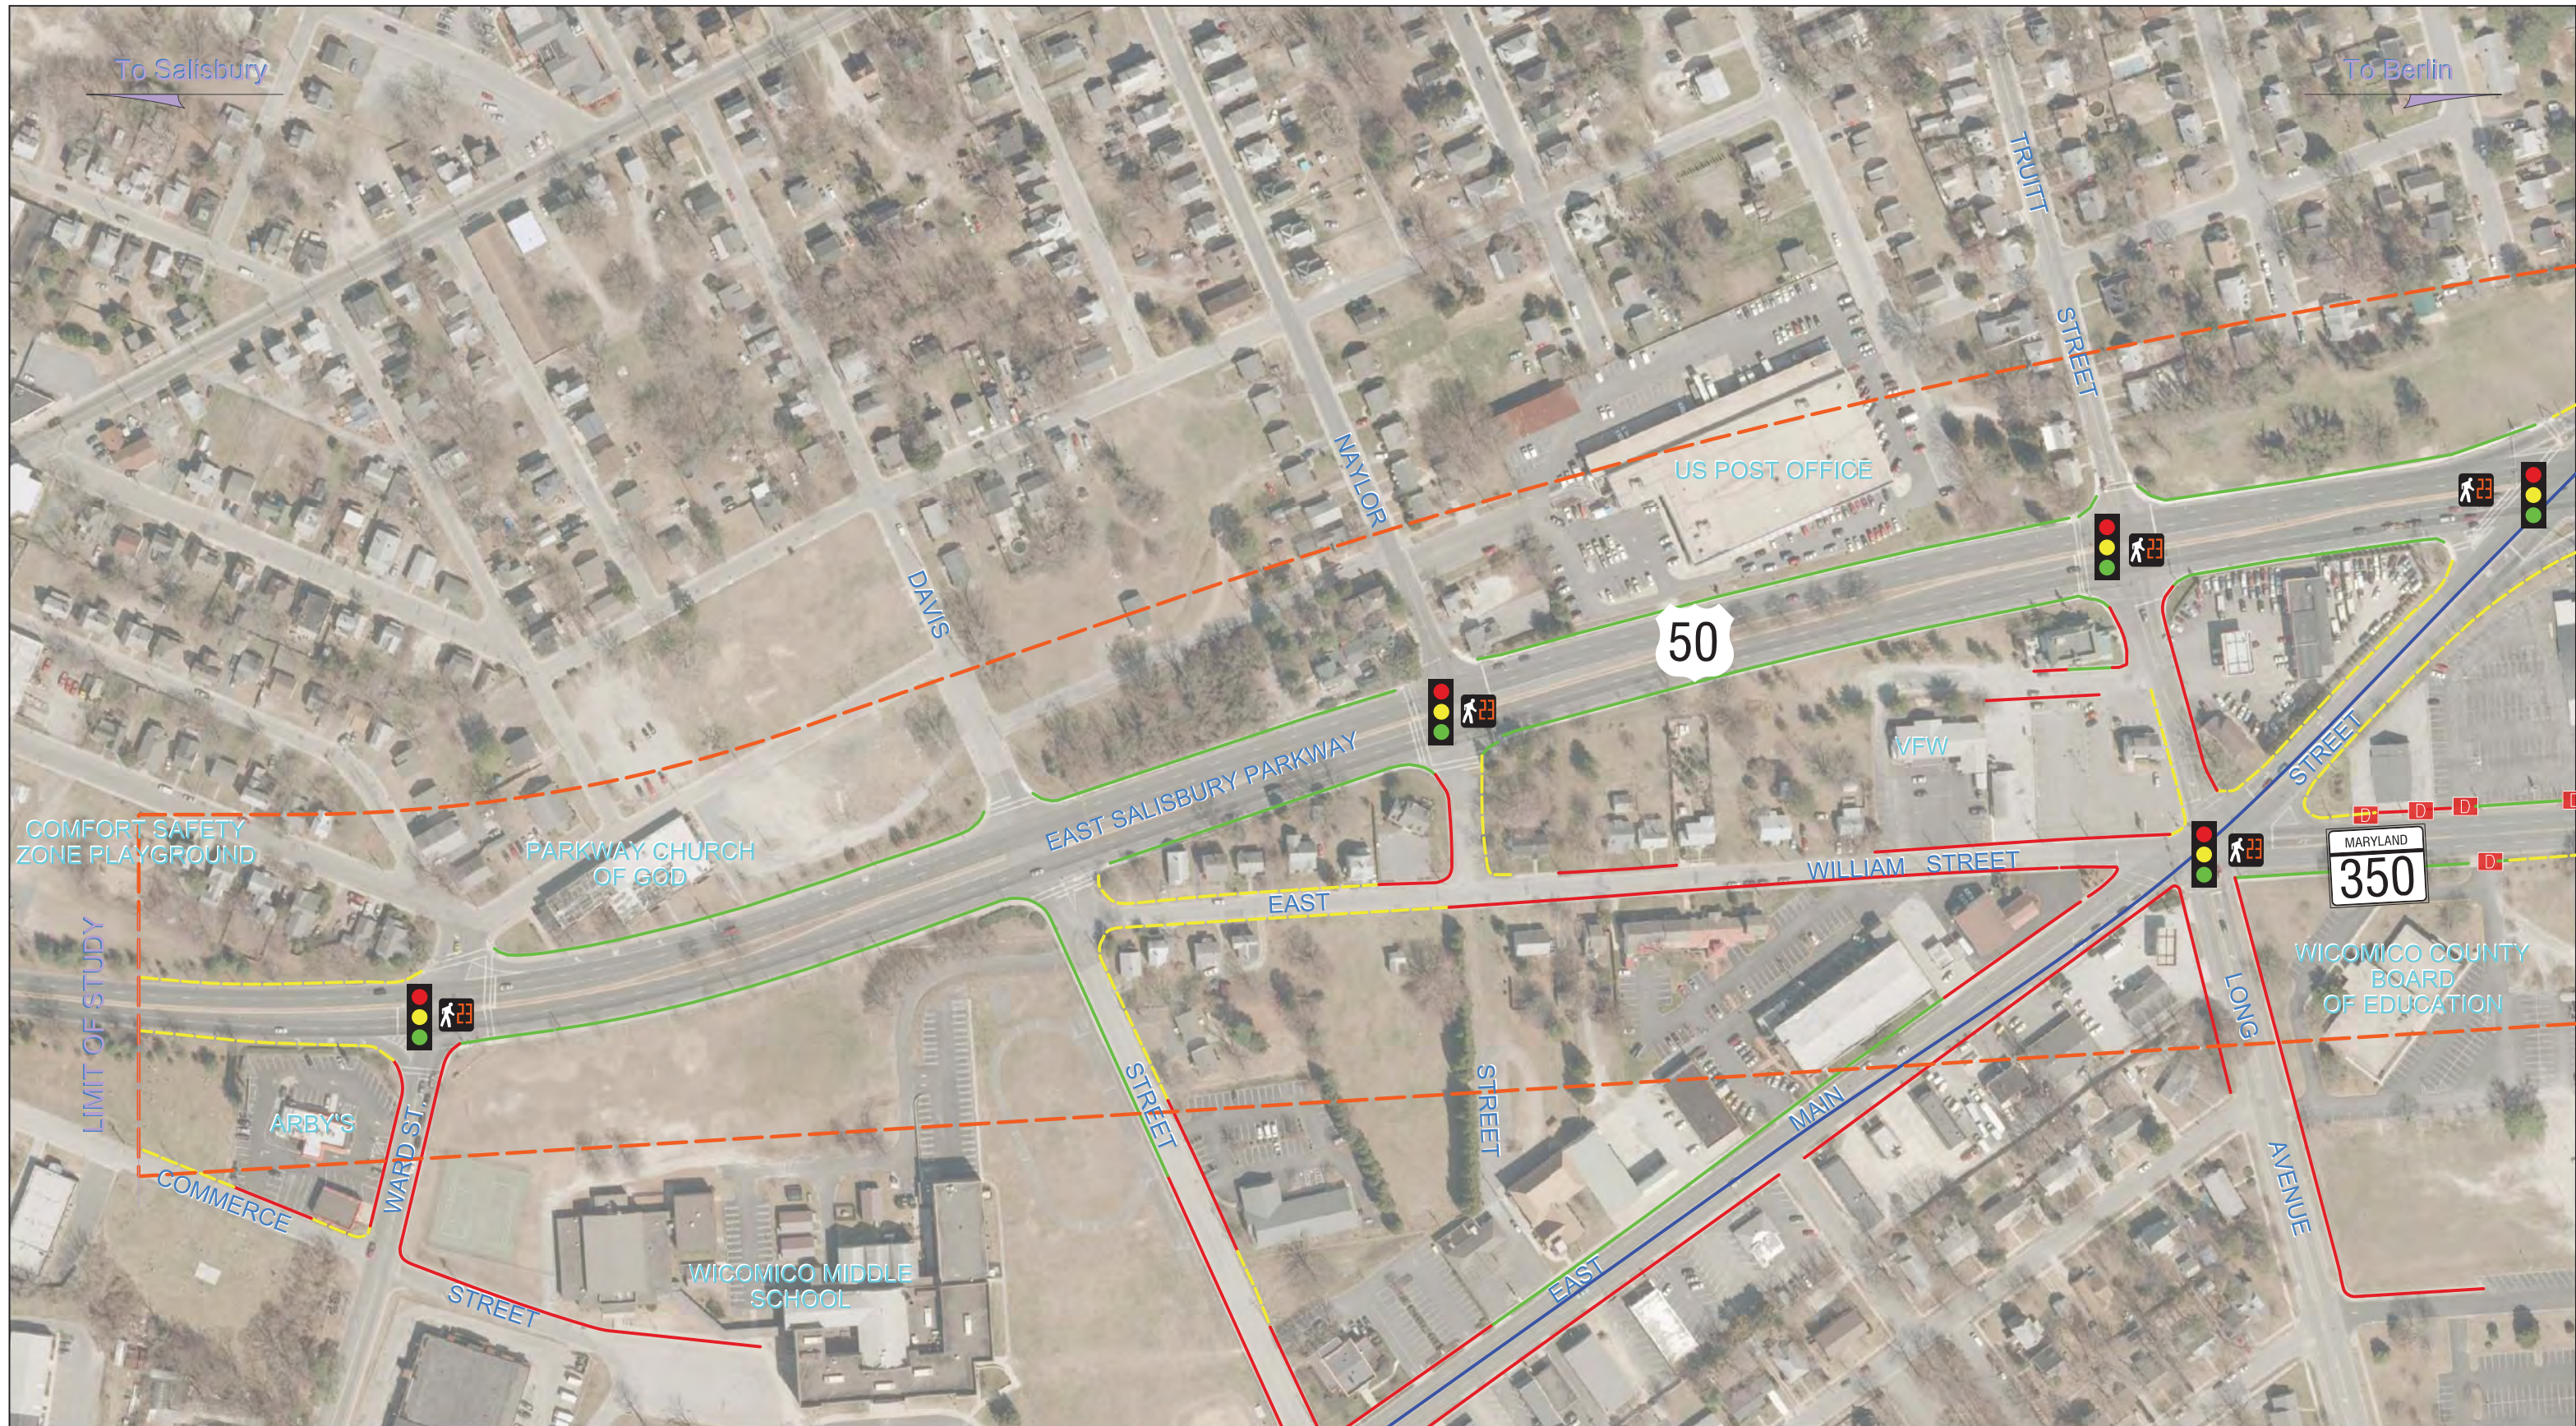
FIGURE NO.  
2

**EXISTING CONDITIONS  
PEDESTRIAN AND BICYCLE FACILITIES**

As shown in **Figures 2-4**, US 50 Business contains sidewalk from Ward Street, and points west, to the East Main Street intersection. At the US 50 Business and East Main Street intersection, pedestrians cannot travel north or south along East Main Street due to missing sidewalk. In addition, pedestrians are also unable to continue east along US 50 Business due to the lack of pedestrian facilities along this section of roadway; therefore, pedestrian must reverse course and travel west along U.S. 50 business.

Aside from the two east-west roadways within the study limits, gaps in sidewalk were found along several of the north-south roadways. These include East Main Street, which is missing sidewalk from Mt. Hermon Road to U.S. 50 Business. See **Figure 2**. In addition, the sidewalk which runs along the north side of U.S. 50 Business does not provide a continuous east-west path within the project limits. Beaglin Park Drive is also missing continuous sidewalk, but a bicycle path (Northeast Collector Trail – Phase 2) is proposed to be constructed. In contrast, the existing sidewalk network was found to be continuous along at least one side of each of the following roadways: Davis Street; Naylor Street; Truitt Street; Civic Avenue; and Beaglin Park Drive.

Within the Study area, several locations were found to have inaccessible sidewalk. These locations include East William Street, East Main Street, and several locations along Mt. Hermon Road. See **Figures 2, 3, and 4**.

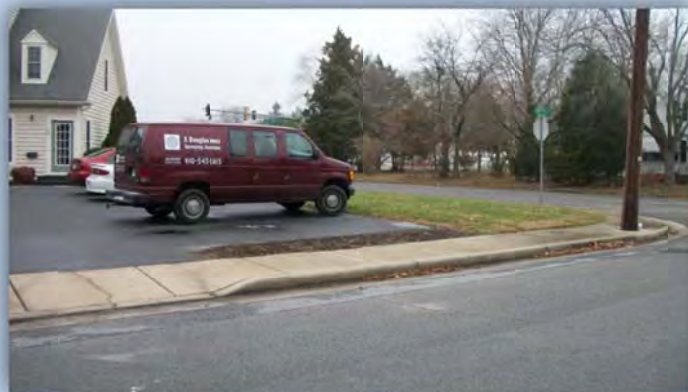
#### **Example Deficiency 2 – Inaccessible Sidewalk**

Inaccessible sidewalks are defined as those currently existing; however, they do not meet the minimum requirements for ADA compliant sidewalk. Inadequate cross slopes, grades, and/or dimensions could each lead to a sidewalk being identified as inaccessible.

- General and ADA pedestrian facility deficiency.
- Unstable/slippery walking surface.
- Excessive cross slope (>2%)
- Lack of 4-foot wide minimum clear.
- Obstructions in path of travel.

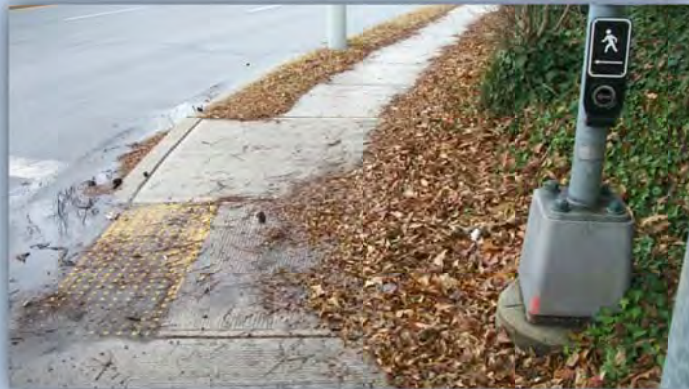
### **Example Deficiency 3 – Deteriorated/Unmaintained Sidewalk**

There were multiple locations throughout the Study area where sidewalk was found to be deteriorated or left unmaintained. These locations can hinder the pedestrian's ability to walk along the intended sidewalk path.

- General and ADA pedestrian facility deficiency.
- Unstable/slippery walking surface.
- Lack of 4-foot wide minimum clear path.
- Detectable warning surface domes filled with debris making detection difficult.

During the field visit, several locations were found to require maintenance. These locations included the U.S. 50 Business and Davis Street intersection corners, sidewalk along eastbound U.S. 50 Business east of Naylor Street, and the sidewalk along East William Street.

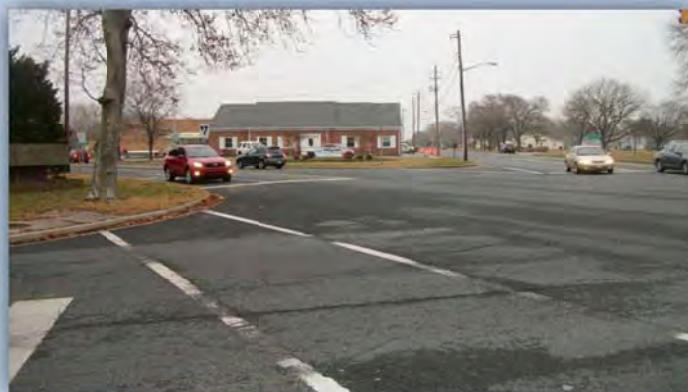
### **Example Deficiency 4 – Missing Pedestrian Curb Ramps**

- General and ADA pedestrian facility deficiency.
- Crosswalk striping indicates intended pedestrian path.
- Lack of curb ramp makes sidewalk inaccessible.

Several intersection corners are currently missing pedestrian curb ramps, these locations include:

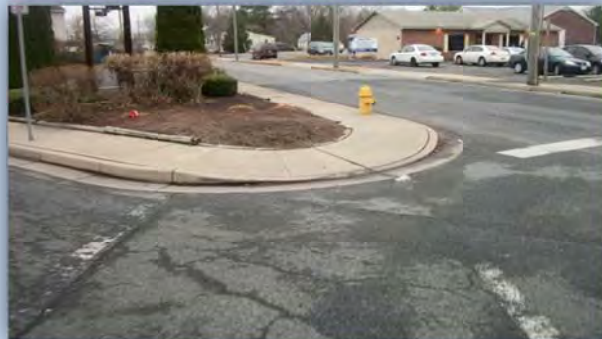
#### **Example Deficiency 5 – Inaccessible Pedestrian Curb Ramps**

Inaccessible pedestrian curb ramps are defined as those that currently exist, but do not meet the minimum requirements for an ADA compliant pedestrian curb ramp. Inadequate cross slopes, grades, widths, or lack of detectable warning surfaces could each lead to a pedestrian curb ramp as being identified as inaccessible.

- **ADA pedestrian facility deficiency.**
- **Cross slopes and ramp transition grades exceed maximum allowable.**
- **No detectable warning surface.**

Several intersection corners currently contain inaccessible curb ramps, these locations include:

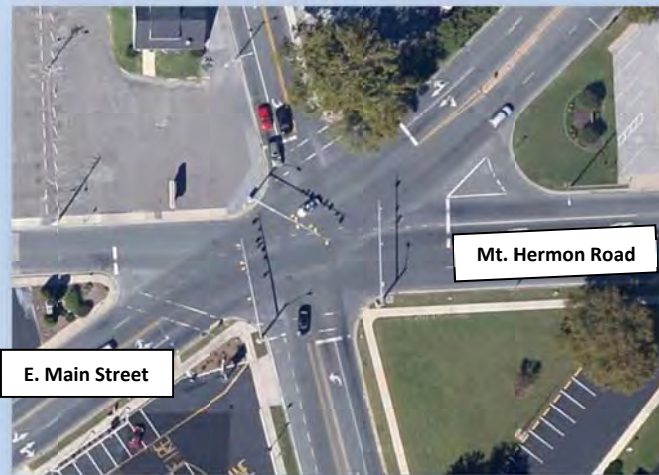
#### **Example Deficiency 6 – Unclear Intended Pedestrian Route**

Several locations within the project limits do not contain clear pedestrian route indications. These locations make it difficult for pedestrians and bicyclists to safely navigate areas within the project limits. Lack of pedestrian ramps, offset curb lines, and lack of/worn crosswalk markings attribute to unclear pedestrian and bicyclist route delineation.

- General pedestrian facility deficiency.
- Unclear intended pedestrian route leads to jaywalking.
- Difficult to navigate intersection for pedestrians and bicyclists.

Several locations exist within the study limits where the intended pedestrian route is either ambiguous or preferred by pedestrians as the route would require a further distance than wanted. These locations include the East Main Street and Mt. Hermon Road intersection and the U.S. Route 50 Business and Davis Street intersection.

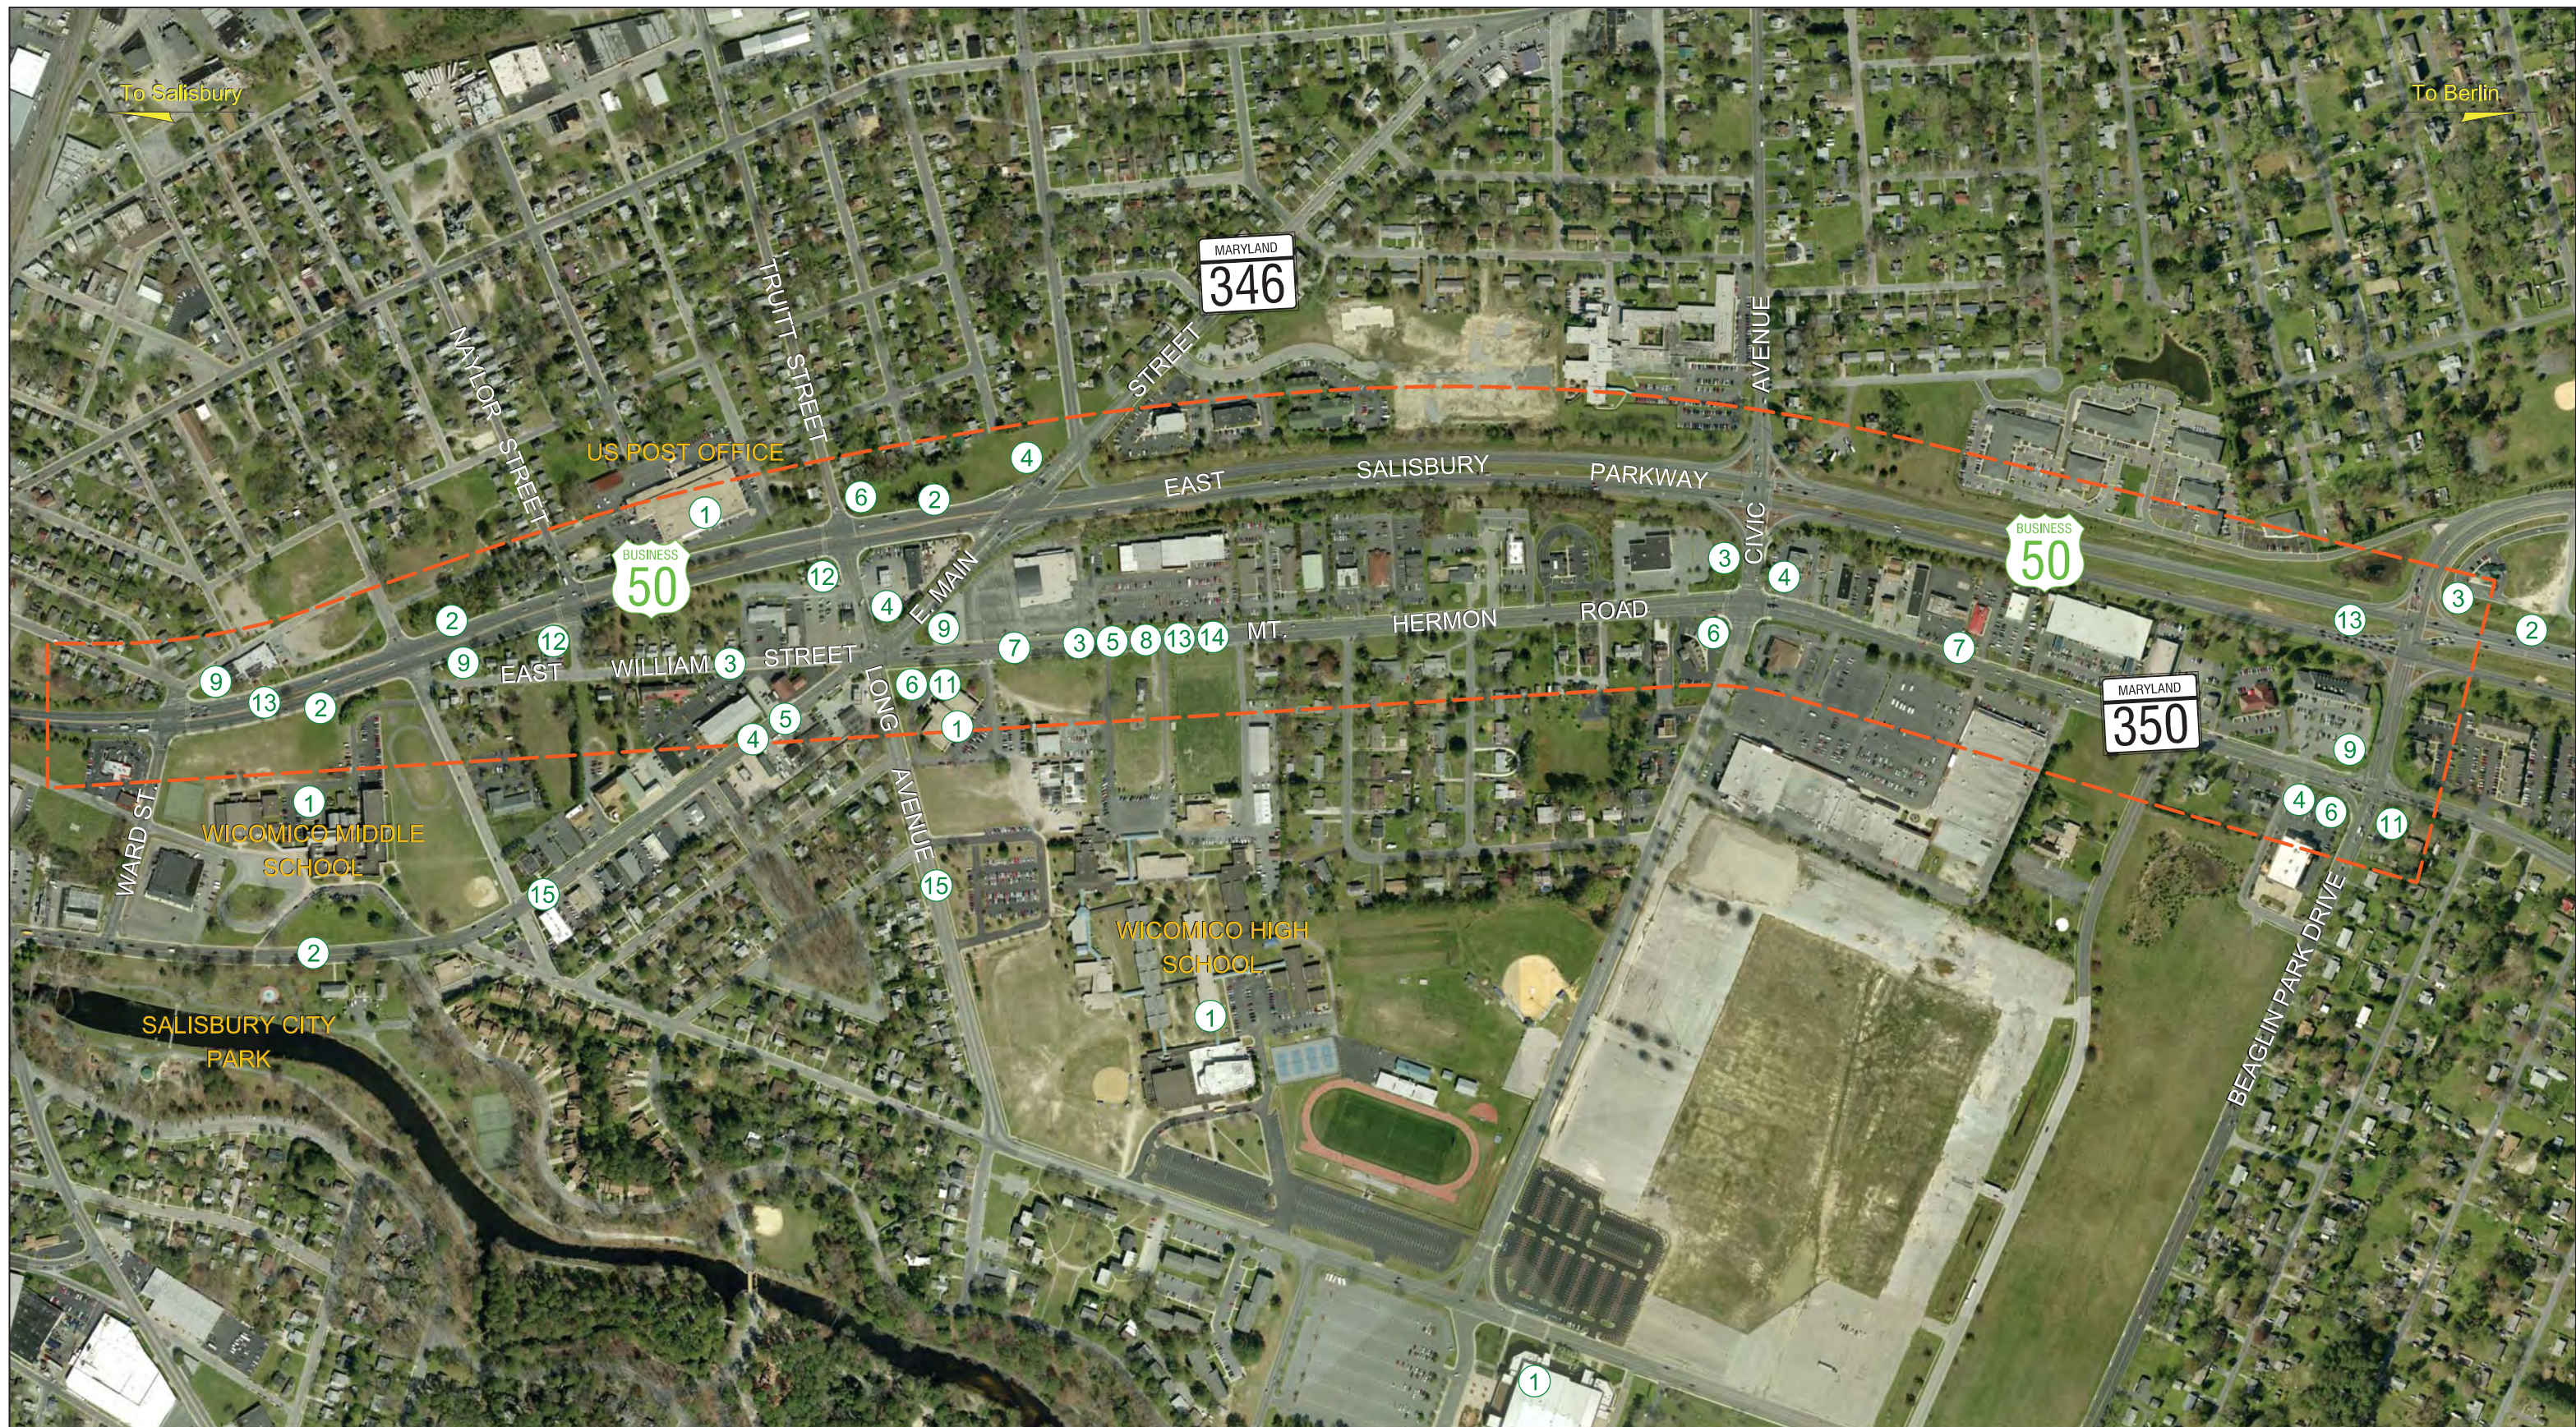
- **Speed Display Unit** – This improvement would include the use of a mobile or permanent speed display trailer to provide active feedback to drivers who may be exceeding the speed limit. This could potentially slow drivers down making it easier for bicyclists and pedestrian to travel along the roadways. Specific locations are identified as Item 2 on **Figure 7**;

- **General Sidewalk Improvements** – This improvement would include the construction of new sidewalk to fill missing links, repair deteriorated sidewalk, and working with homeowners to enforce sidewalk cleaning. Specific locations are identified as Item 3 on **Figure 7**;

- Transit Stop Improvement – This improvement would involve the addition of vegetation, passenger shelters, and general beautification at transit stops. The locations identified for this improvement are noted as Item 7 on **Figure 7**;

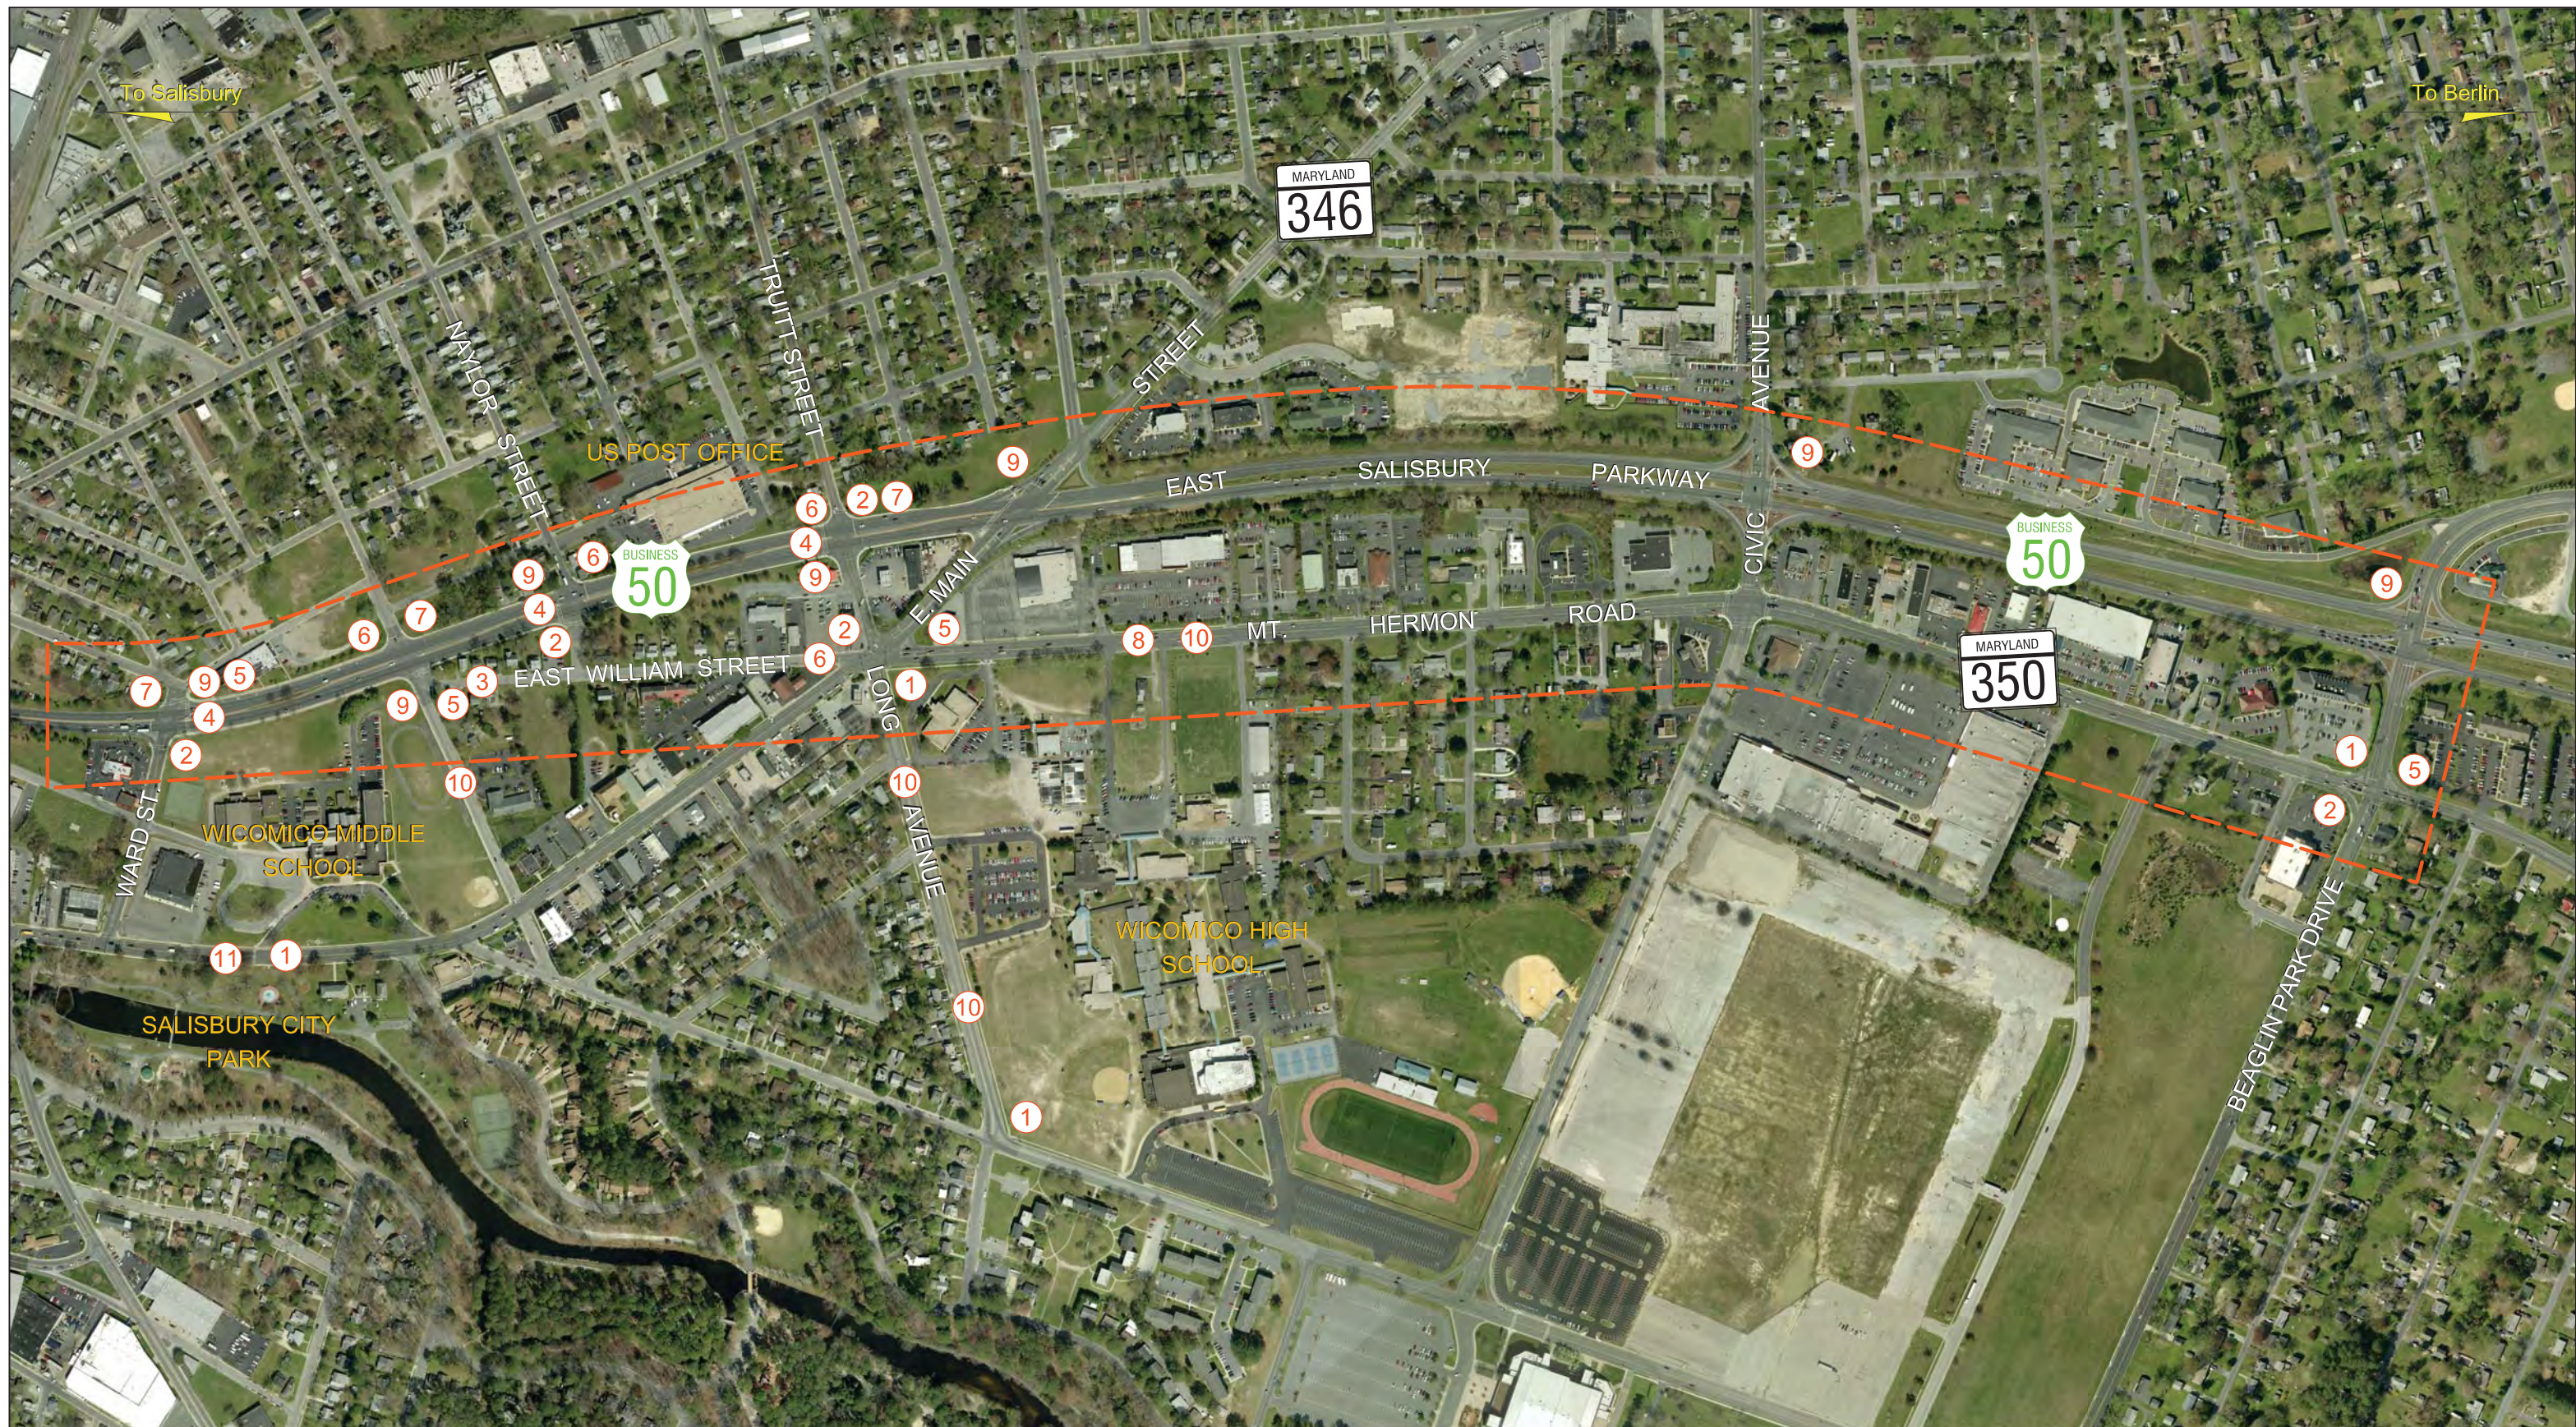
The Level 2 Improvements are characterized as having relatively moderate impact from both a physical footprint perspective and a user's inconvenience perspective during installation. Some of these improvements would build upon Level 1 Improvements making them permanent. These improvements would also have relatively moderate cost to install as compared to Level 3 recommendations. As with the Level 1 Improvements, these improvements may require additional study prior to implementation. These improvements are focused on specific locations within the study limits and are illustrated in **Figure 8**. The Level 2 Improvements include the following:

- **Conversion to One-Way** – This improvement would convert an existing two-way roadway to one-way. One location within the study area, East William Drive from East Main Street to Davis Street, would be suitable for conversion to a one-way roadway (westbound) and is identified as Item 3 on **Figure 8**;

- **Pedestrian Refuge Island Modification** – These improvement locations are identified as Item 4 on **Figure 8**. These improvements are needed in order to make the existing refuge islands along

- Conversion of Painted Channelizing Islands – These improvement locations are identified as Item 5 on **Figure 8**. These improvements would include the elimination of the existing painted pavement channelizing islands and replacement with raised islands. These locations would not only physically restrict vehicles from traveling over the painted island, but would also serve as a refuge area for existing pedestrian crossings. For example, the U.S. 50 Business and Ward Street intersection contains two painted channelizing islands. By replacing these painted islands with physical islands, the crosswalks could be relocated to provide shorter pedestrian crossing distances and bring the pedestrians into the driver's view by placing them closer to the intersection. This improvement is presented in **Figure 9**.

Curb Radius Reduction/Curb Extensions – These improvement locations are identified as Item 6 on **Figure 8**. These improvements would include the extension of the existing curb line and/or reduction of existing curb line radii. This improvement would reduce the distance a pedestrian is required to cross and also require vehicles to slow as they rounded the intersection corners. With this improvement roadway drainage patterns would need to be analyzed for the existing and proposed systems. An example of this improvement at the north leg of the US Route 50 Business and Truitt Street intersection and is presented in **Figure 10**.

- Lane Narrowing - Locations proposed for these improvements identified as Item 8 on **Figure 8**. This improvement would include the elimination of one westbound and one eastbound lane on Mt. Hermon Road from the East Main Street intersection to the Beaglin Park Drive intersection.

- Lighting Improvements – Locations proposed for these improvements are identified as Item 9 on **Figure 8**. These locations are specifically targeted toward the Ward Street, Davis Street, Naylor Street, Truitt Street, East Main Street, and Civic Avenue intersections with U.S. Route 50 Business. Currently, where lighting exists at these intersections, it is generally located on the opposite side of the roadway from the pedestrian crossing. By adding lighting to the side of the roadway with the marked pedestrian crossings, pedestrian will be more visible to drivers.
- Chokers – These improvement locations are identified as Item 10 on **Figure 8**. Chokers can be installed on one, or both sides of the roadway and act as a traffic calming measure. Chokers are generally installed on wider roadways where vehicle speeds are greater than desirable.

- Hawk Signal – One location was identified as being a potential location to install a HAWK signal. This location is presented as Item 11 on **Figure 8** and would be at the existing mid-block pedestrian crossing of East Main Street at Wicomico Middle School. A HAWK signal, or HAWK beacon, is a pedestrian actuated traffic signal remaining dark until a pedestrian approaches the crosswalk and actuates the signal. An example HAWK signal is presented in **Figure 11**.

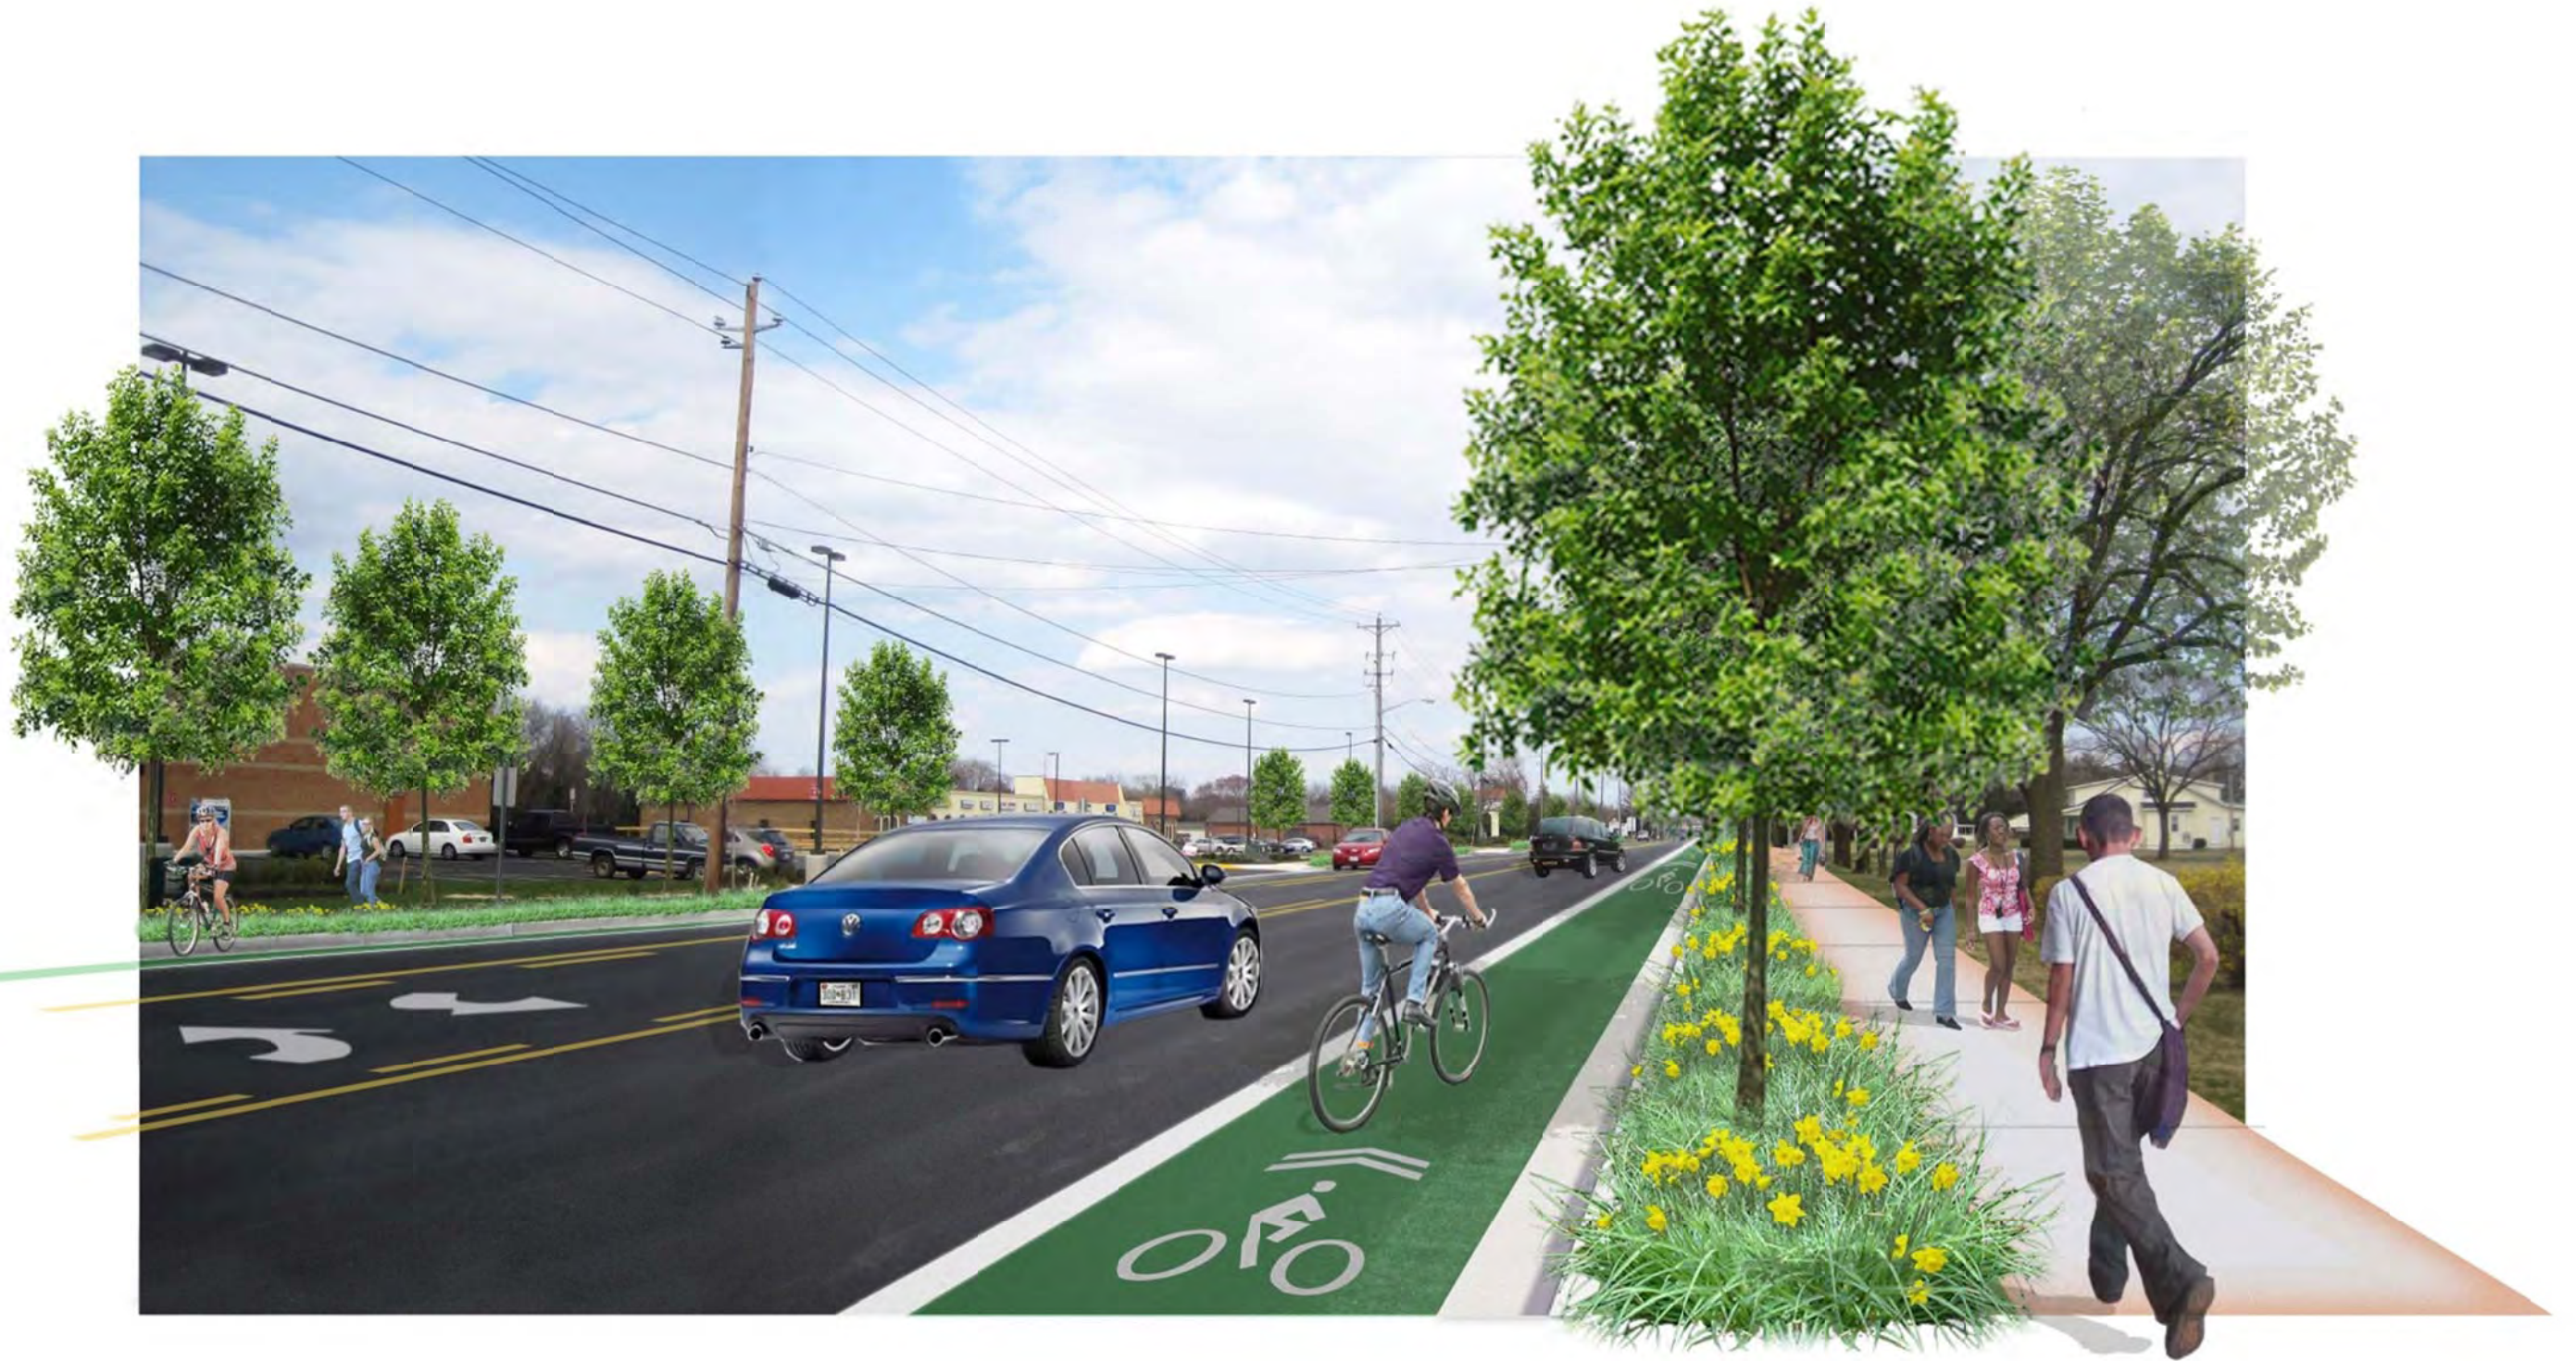
Figure 19: Graphical Rendering of Mt. Hermon Road “Road Diet” Targeted Improvement

This corridor is well suited for a “Road Diet.” Application of a Road Diet to this corridor would involve restriping the entire roadway to include one westbound lane, one eastbound lane, and one center two-way-left-turn-lane as shown in **Figures 15-18**. A Road Diet is generally applicable on roadways with average daily traffic volumes of 20,000 vehicles or less under, which Mt. Hermon Road operates. In addition to this modification, an on-road dedicated bicycle lane would be added in each direction. This bicycle lane would connect the proposed Beaglin Park Drive bike path located at the eastern terminus to the East Main Street State bicycle route and Salisbury City Park at the western terminus. Application of this improvement would allow turning vehicles to enter the center turn lane prior to turning and would also require those vehicles to yield to only one lane of oncoming traffic. The cost associated with this Level 3 recommendation would essentially be negligible if the improvement is applied during the next scheduled resurfacing project for Mt. Hermon Road. However, if the improvement were to be programmed, the cost of the full improvement is estimated at approximately \$800,000. A graphical rendering of this improvement is presented in **Figure 19**.
